WL-TR-97-3093

**CORROSION AND FATIGUE STUDY
OF JSTARS AIRCRAFT**

Volume I

**NORTHROP GRUMMAN CORPORATION
MILITARY AIRCRAFT SYSTEM DIVISION
ONE HORNET WAY
EL SEGUNDO, CA 90245**

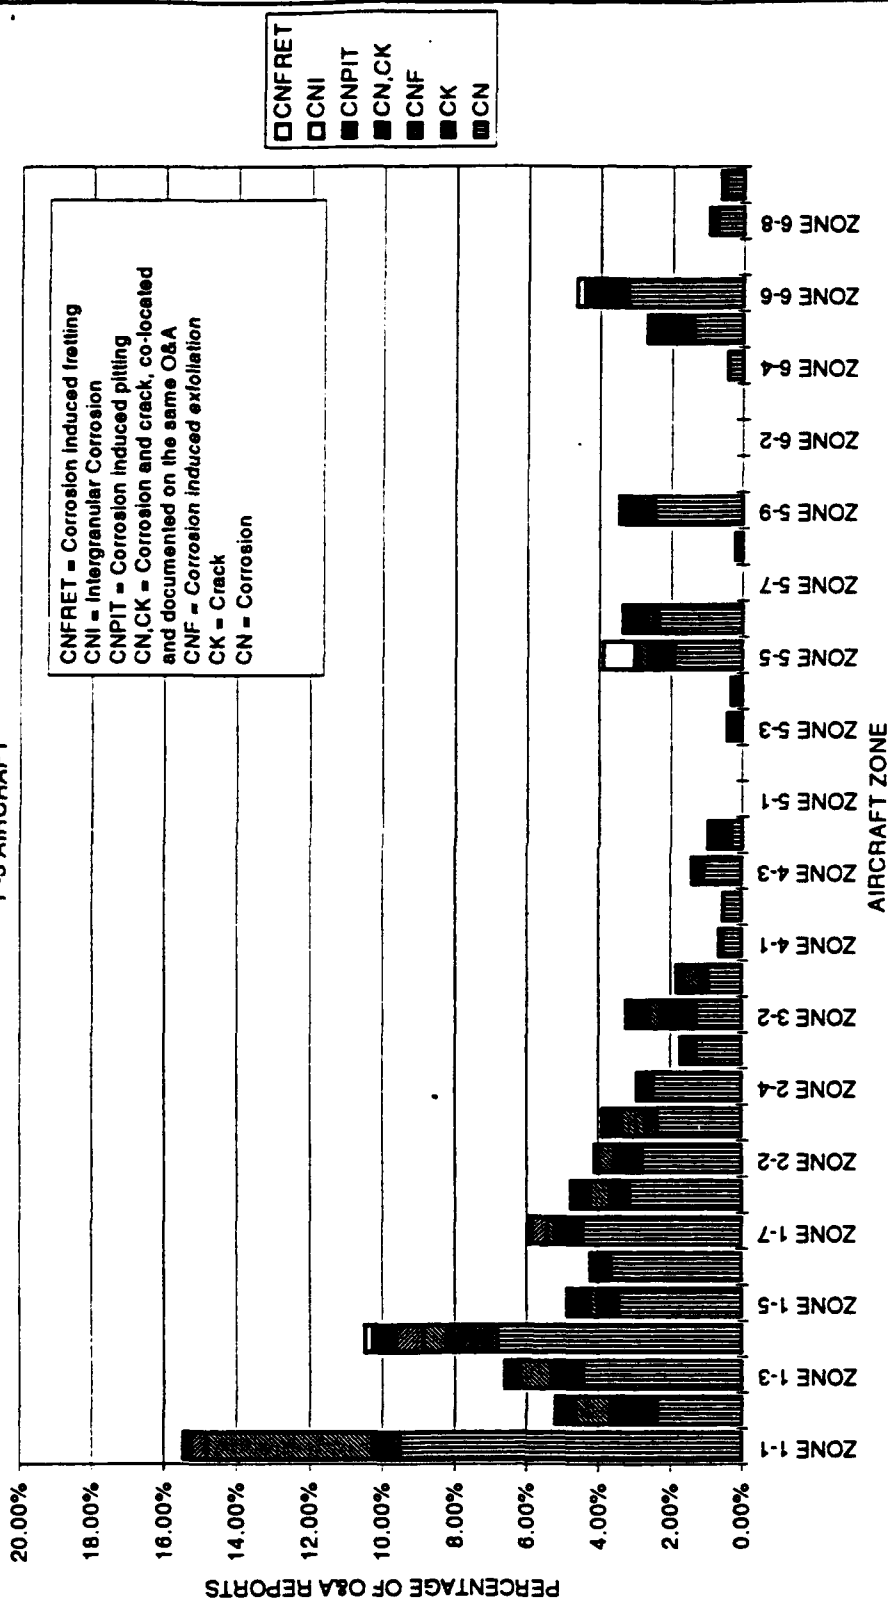
Figure 4.2 and 4.3 report the percentage of over and above (O&A) reports per aircraft zone for P-3 and P-4 respectively. The levels of damage trend consistently between aircraft in zones 1-1, 1-4, 5-5, 5-6, 6-5 and 6-6. The P-4 aircraft has high levels of damage in zones 2-2 and 2-4 which are not present on aircraft P-3. Conversely, the P-3 aircraft has a relatively high level of damage in zone 5-9 not seen on the P-4 aircraft.

Figure 4.2 - Percentage Of O&A Reports Per Aircraft Zone On Joint STARS Aircraft P-3

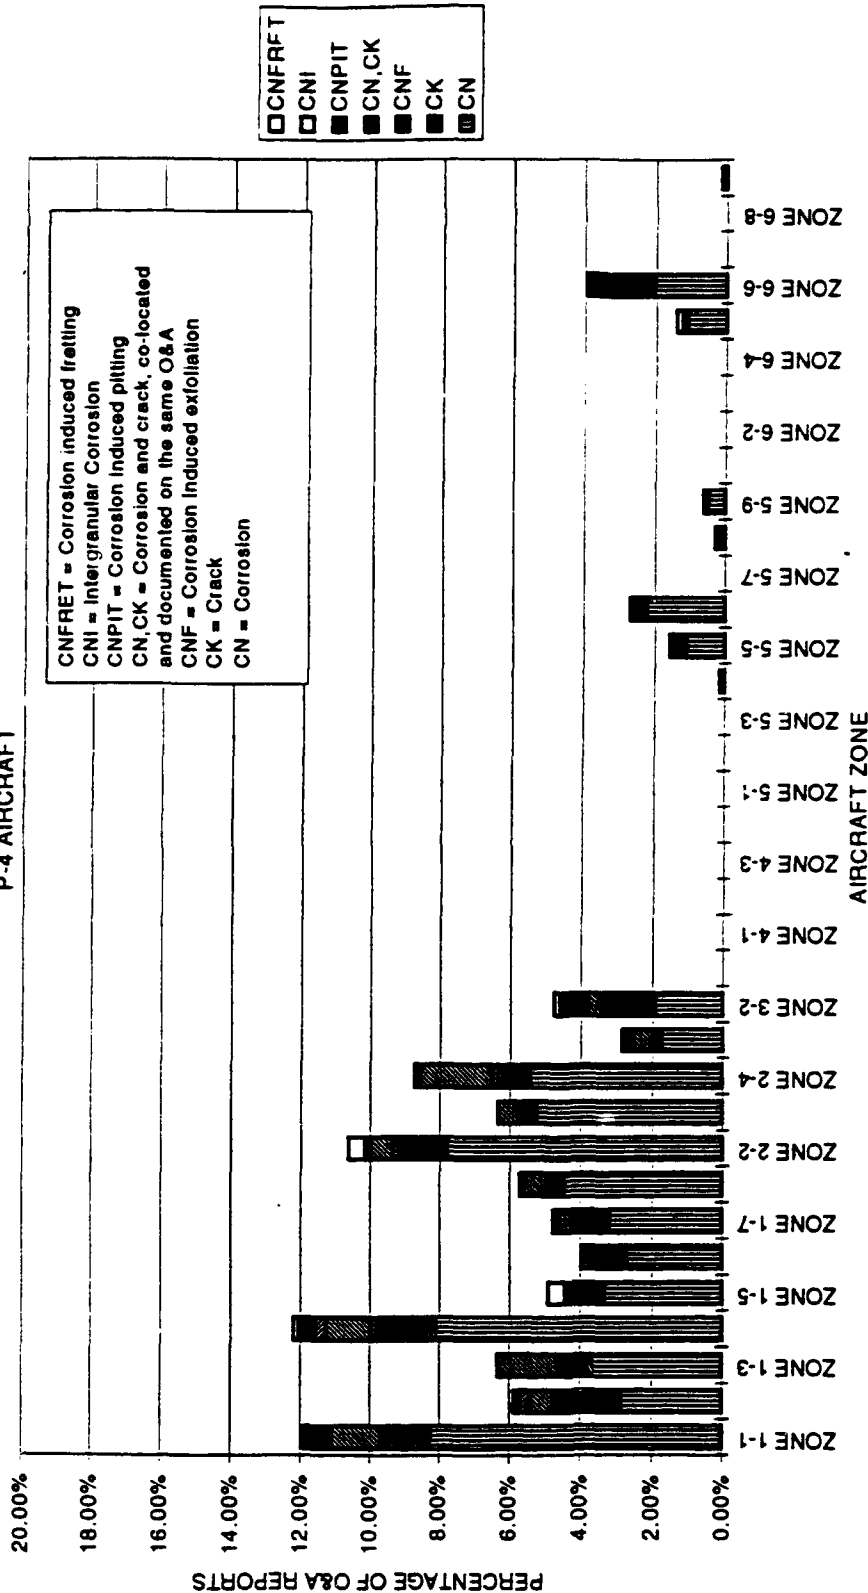
Figure 4.3 - Percentage Of O&A Reports Per Aircraft Zone On Joint STARS Aircraft P-4

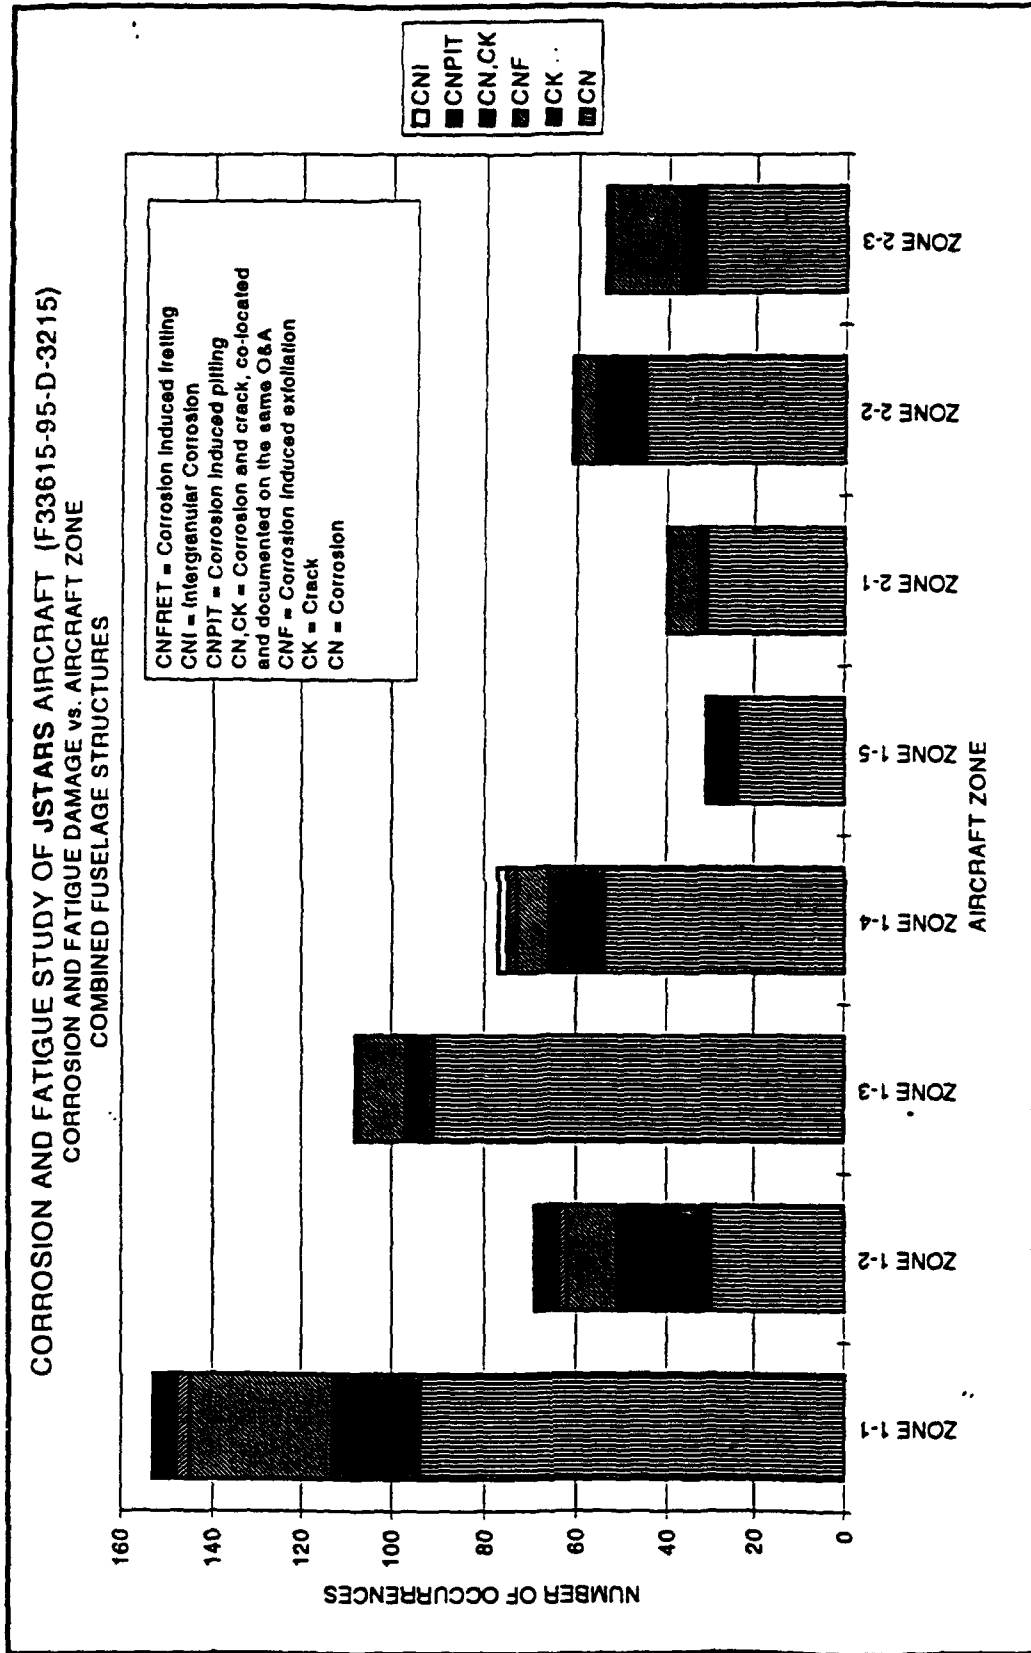
As shown in Figure 4.4, the internal structures of the lower fuselage zones of the aircraft surveyed were found to be the areas of highest corrosion and fatigue damage. Zones 1-1 through 1-4 consistently exhibited a higher level of damage than zones 2-1 through 2-3. This seems to disagree with Figure 4.1 which shows zone 2-3 with a higher level of damage than zone 1-2. However, Figure 4.4 only accounts for internal structures while Figure 4.1 includes skin panels and stringers.

Figure 4.4 - Corrosion And Fatigue Damage On Internal Fuselage Structures Per Aircraft Zone On Joint STARS Aircraft P3 And P4

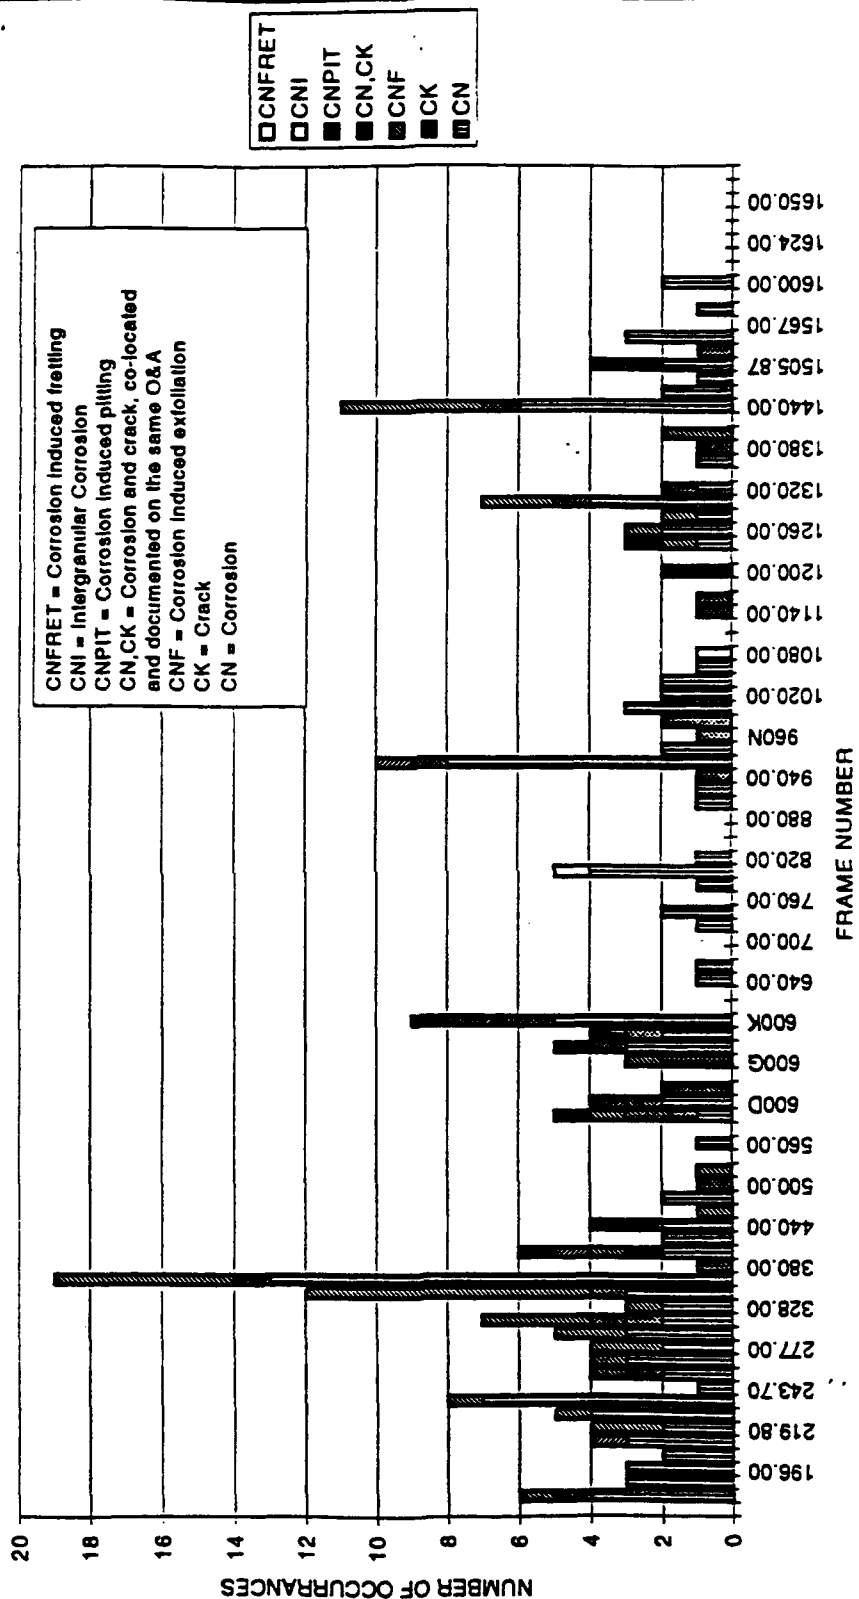
Figure 4.6 - Corrosion And Fatigue Damage Specific To Frames And Bulkheads On Joint STARS Aircraft P3 And P4

The corrosion and fatigue damage located between BS 200 and BS 360 can be largely attributed to the nose landing gear wheel well. The frames in this area, as shown in Figure 4.6, have a slightly elevated level of damage in comparison to the rest of the aircraft. The notable exceptions are BS 344 and BS 360, which display increased flaw density. As shown in Figure 4.7, the majority of the flaws between BS 200 and BS 360 are not associated with specific frames. Rather, they are located in the inter-frame structures specific to the nose landing gear. The non frame specific damage sites in addition to the flaw density on frames 344 and 360 make the region between BS 200 and BS 360 in zone 1-1 the most severe corrosion and fatigue damage site for internal fuselage structures.

- **BS 360 FRAME.** The forward toilet is located at BS 360 - BS 380. This frame is subjected to the corrosive effects of any spillage from the lavatory tanks as well as the nose landing gear wheel well up splash as previously discussed. As evident in Figure 4.6, the combination of these two corrosion sources subjects this frame to an extremely aggressive environment, making this the most corrosion prone frame on the aircraft.

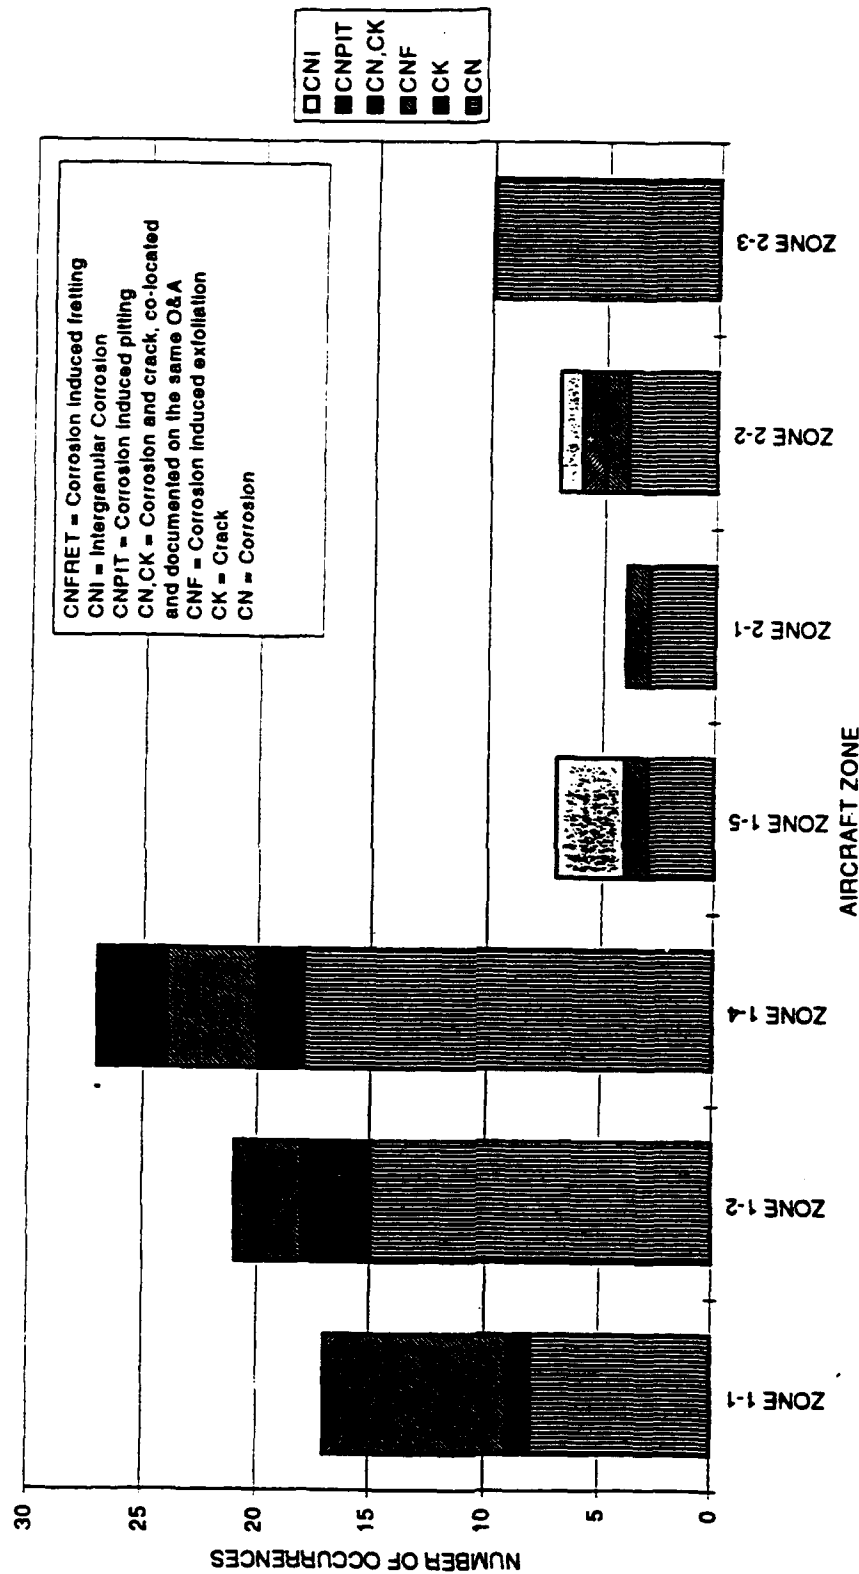
Fuselage stringers display the highest density of corrosion and fatigue damage in zones 1-1, 1-2, and 1-4, the belly of the aircraft. Further inspection within the aircraft zones does not reveal any strong patterns associated with the distribution of damage sites. In any given aircraft zone, the distribution of damage sites is fairly random with respect to body station and stringer number. Zone 1-4 displays the highest density of corrosion and fatigue damage, as indicated in Figure 4.8.

Figure 4.8 - Fuselage Stringer Corrosion And Fatigue Damage Per Aircraft Zone On Joint Stars Aircraft P3 And P4

- **LOWER FUSELAGE** Increased corrosion in the lower portion of the fuselage is readily explained by that region's exposure to splashed water from the ground and the propensity for external moisture to accumulate there. In addition to these external conditions, the lower regions are also subjected to moisture accumulation from within the aircraft, which gets trapped in the insulation and remains there for extended periods. This mechanism of internally generated corrosion is most evident in Figure 4.8, which shows the elevated corrosion levels of the lower stringers.

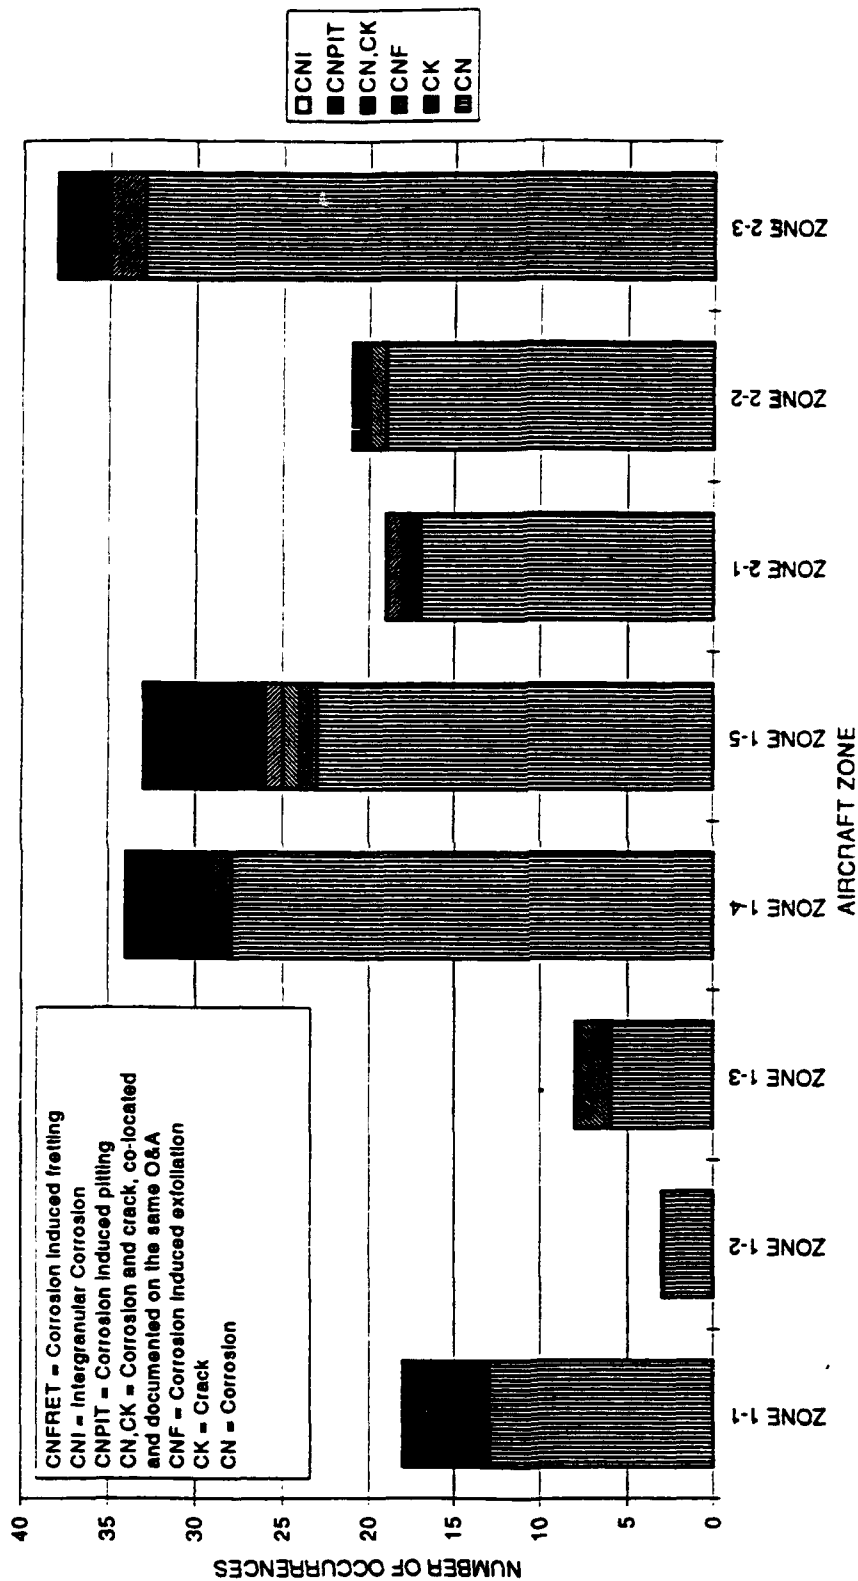
As shown in Figure 4.9, zone 1-4, zone 1-5, and zone 2-3 contain elevated levels of corrosion and fatigue damage on the skin panels. In addition to these zones, the nose of the aircraft, forward of BS 259.5, comprising of aircraft zones 1-1 and 2-1, also shows elevated levels of corrosion and fatigue damage.

Figure 4.9 - Fuselage Skin Panel Corrosion And Fatigue Damage Per Aircraft Zone On Joint Stars Aircraft P3 And P4

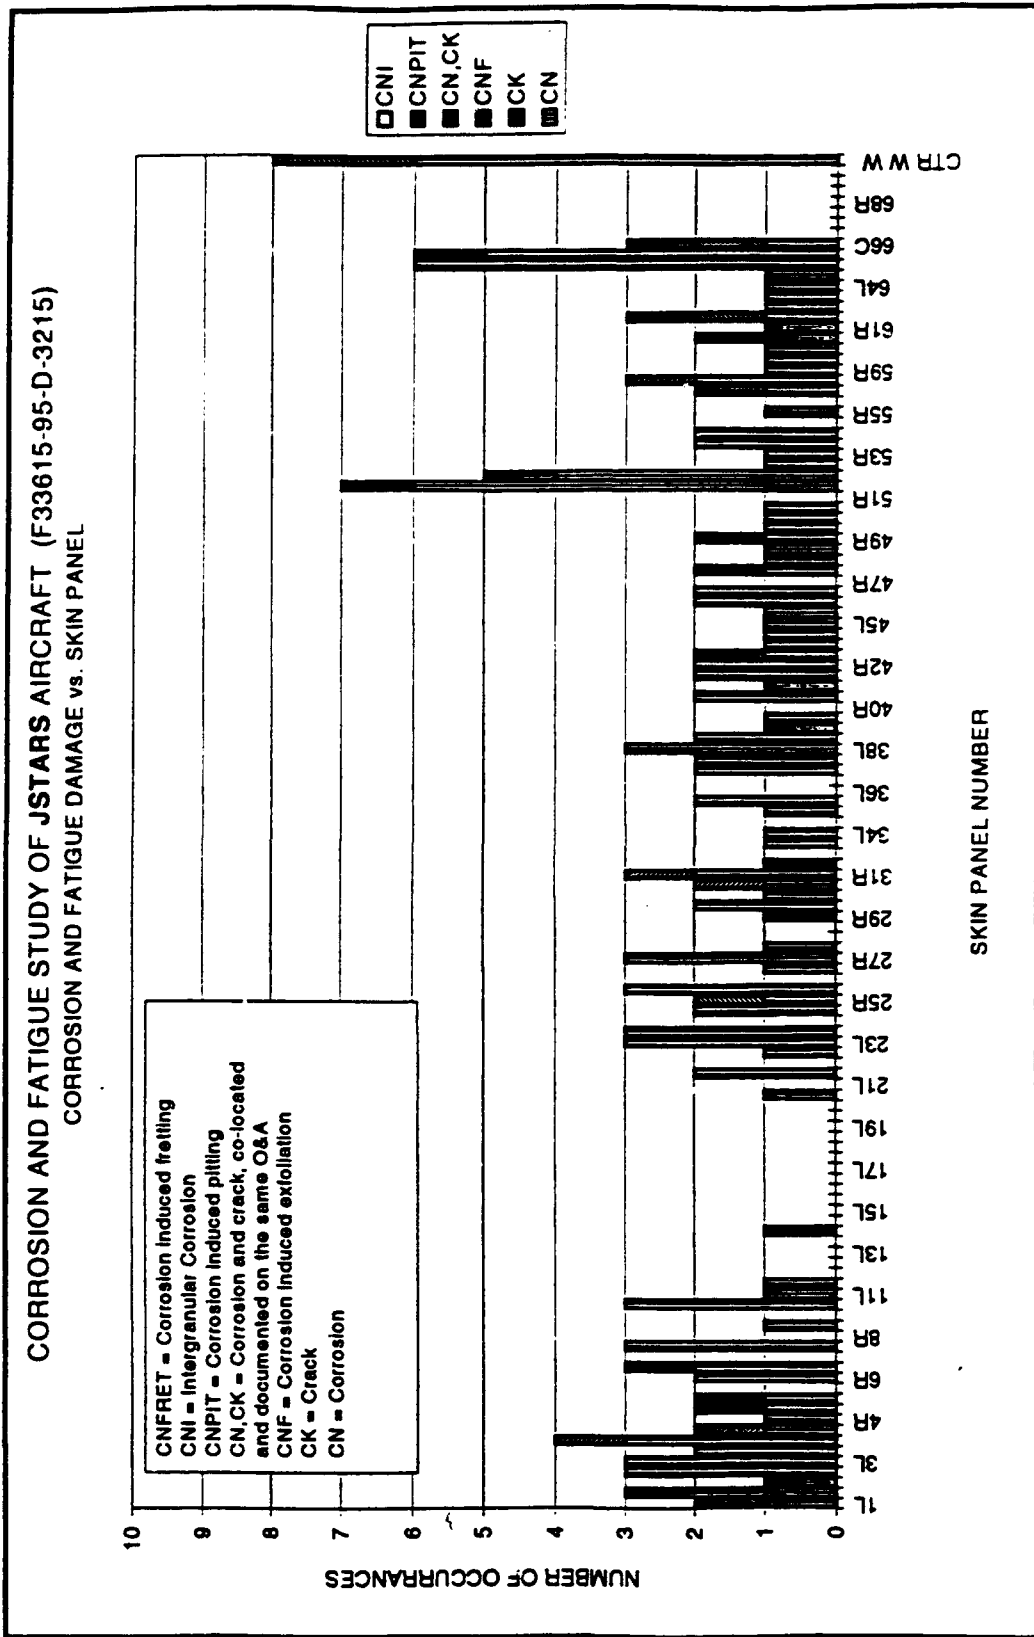
The distribution of skin panel damage is fairly uniform with the exception of a few skin panels. There is a lack of damage ranging roughly from skin panel 6R/L to 24R/L. This lack of damage sites (Figure 4.10) is due to the fact that these skin panels are subject to replacement per contract. Conversely, skin panels 52L and 52R, located between BS 1240 and BS 1440 in aircraft zone 2-3 exhibit high levels of damage. Similarly, skin panels 65L and 65R located between BS 1505 and BS 1592 also exhibit high damage levels.

Figure 4.10 - Fuselage Skin Panel Corrosion And Fatigue Damage Per Skin Panel On Joint Stars Aircraft P3 And P4.

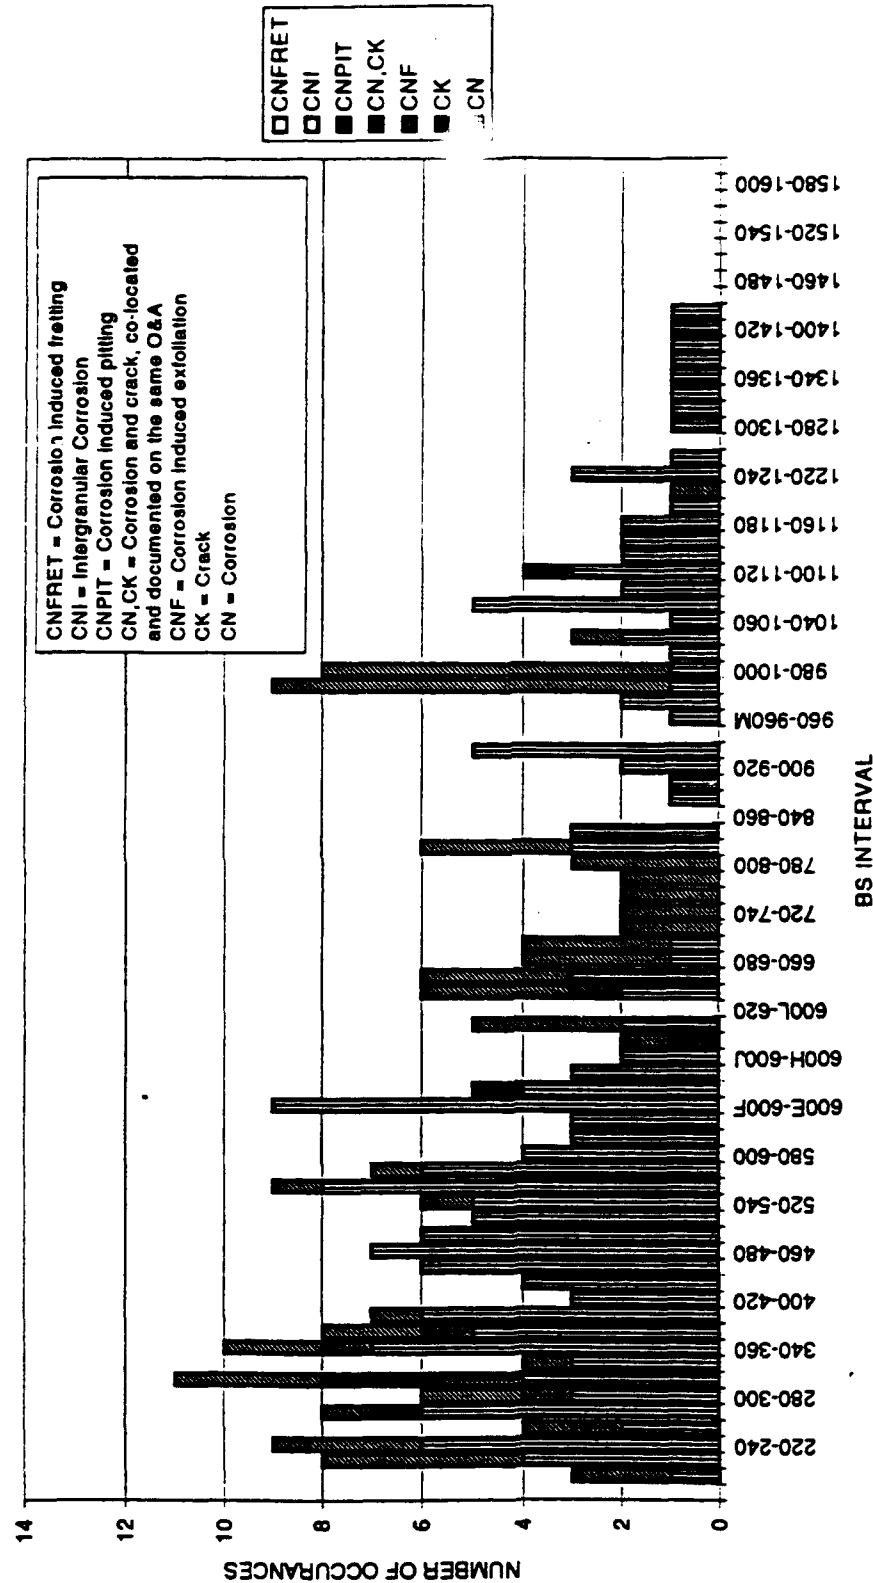
The aircraft zone containing the most defects is zone 2-4. The majority of floor beam corrosion and fatigue damage sites are located forward of BS 600K. Of particular note for the high level of damage sites are the floor structures from BS 200 to BS 400, and the area between BS 440 and BS 580. Further aft, the floor structures between BS 960N and BS 1000 are unique for their elevated levels of exfoliation. To a lesser degree, there is also an elevated level of exfoliation between BS 600J and BS 820, which is the floor above the center wing section. The corrosion and fatigue damage in the floor structures is represented in Figure 4.11.

Figure 4.11 - Fuselage Floor Beam Corrosion And Fatigue Damage Per 20 Inch Segment On Joint STARS Aircraft P3 And P4

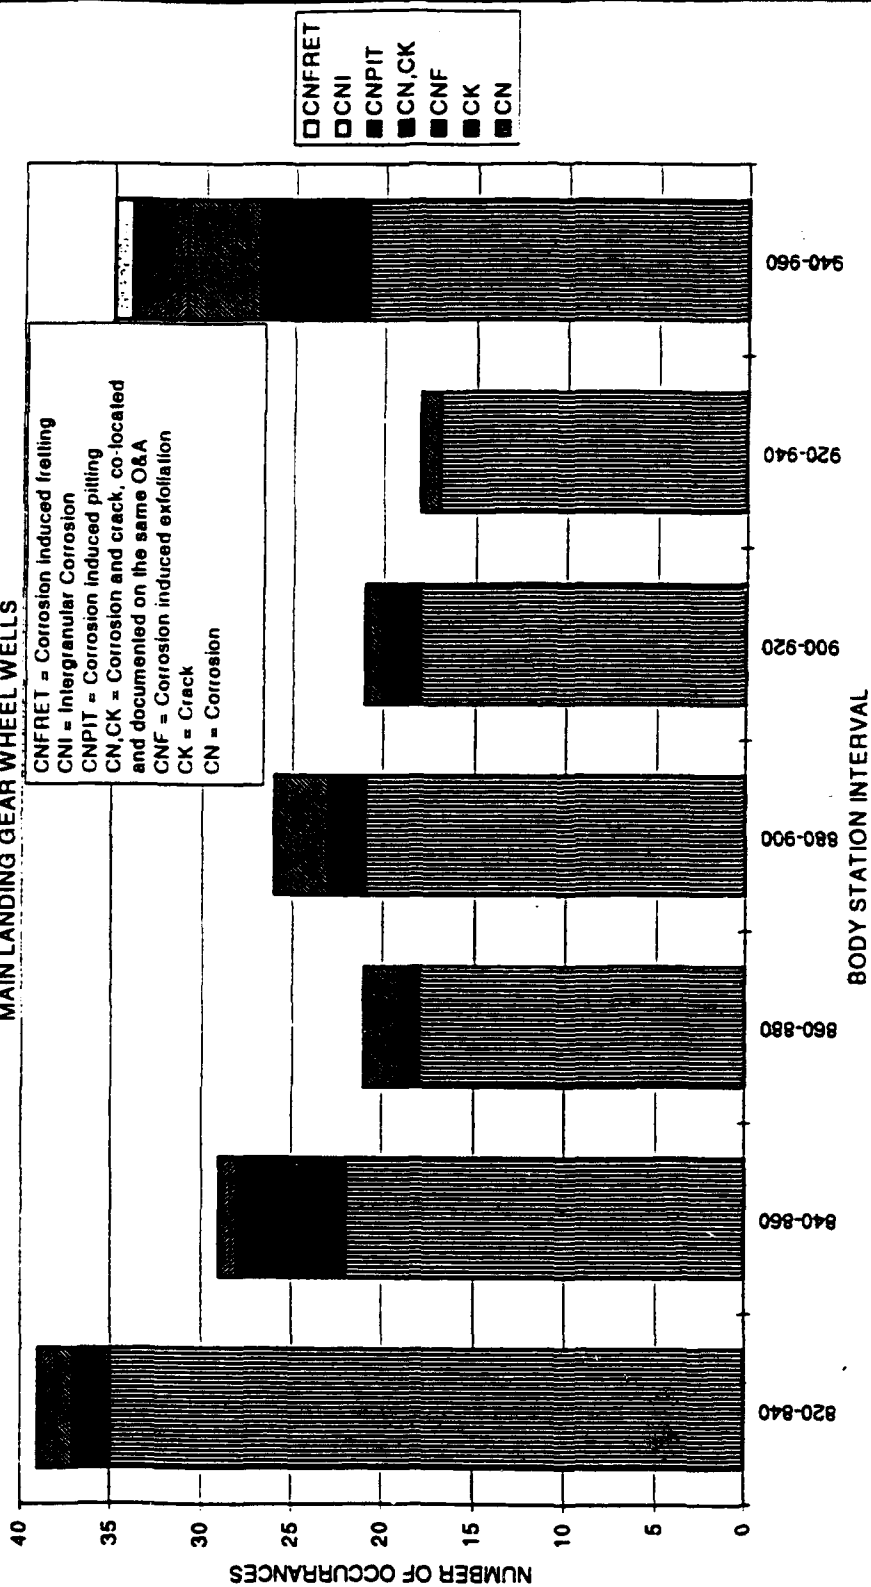
Aircraft zones 1-6 and 1-7 display high levels of corrosion and fatigue relative to zone size. The locations of the damage sites are presented in Figure 4.12, which segregates the data into 20 inch body station intervals. The level of damage per body station interval remains relatively level between BS 820 and BS 960. There are elevated levels of damage at BS 820 and BS 960, which are the fore and aft bulkheads of the wheel wells.

Figure 4.12 - Main Landing Gear Wheel Well Corrosion And Fatigue Damage Per Body Station Interval On Joint STARS Aircraft P3 And P4.

- **BS 820 - BS 960** The main landing gear wheel wells experience conditions very similar to those experienced by the nose landing gear wheel well. The up splash

from takeoff, landing and taxi introduces the conditions that initiate corrosion. The instances of reported cracking in this area are minimal.

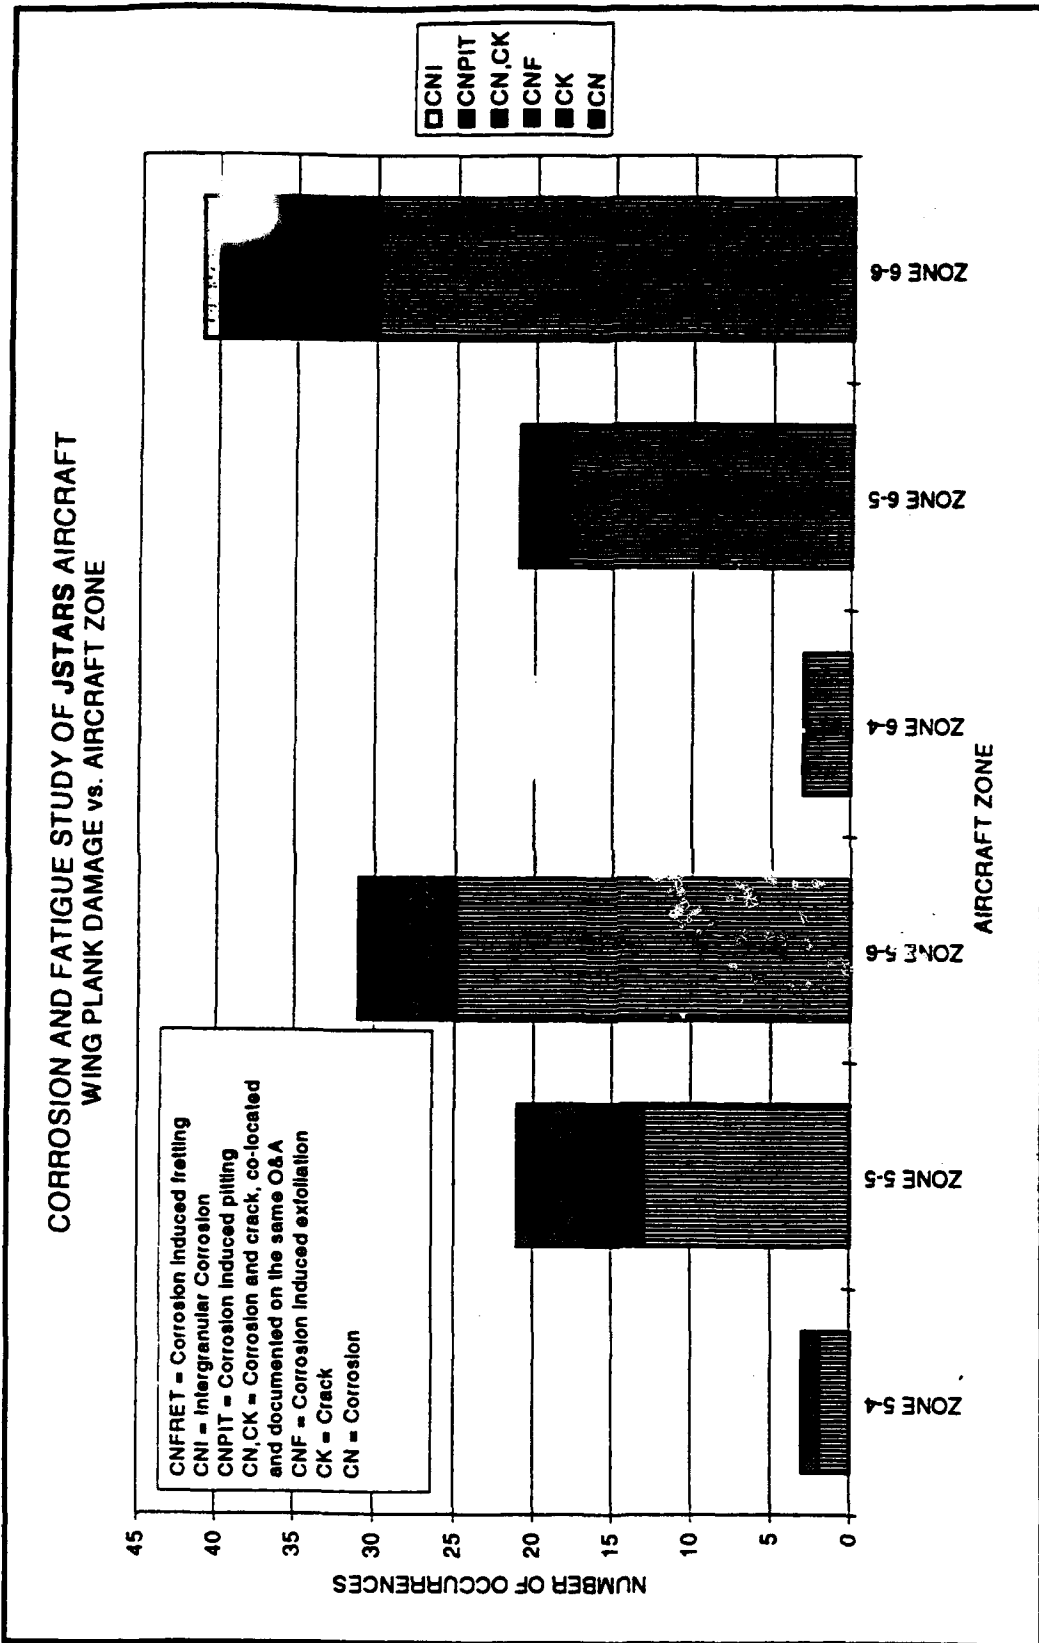
Over half of the corrosion and fatigue damage on the wings of the P-3 and P-4 aircraft involves the wing planks and stringers. As indicated in Figure 4.13, the highest damage levels are located on the inboard wing planks, in aircraft zones 5-6 and 6-6. The corrosion and fatigue damage levels remain relatively high in zones 5-5 and 6-5, then drastically decrease in the outboard wing zones 5-4 and 5-5. The type of damage found in the wing planks remains symmetric between the left and right sides of the aircraft except for two notable exceptions. Zone 6-6 displays a higher level of fatigue cracks than zone 5-6; this is a condition found on the P-4 aircraft. There is also presence of exfoliation in zone 5-5 which is not present in zone 6-5. This discrepancy is limited to the P-3 aircraft.

Figure 4.13 - Wing Plank Corrosion And Fatigue Damage Per Aircraft Zone On Joint STARS Aircraft P3 And P4.
